September 2005

HEARST MEMORIAL GYMNASIUM

Historic Structure Report

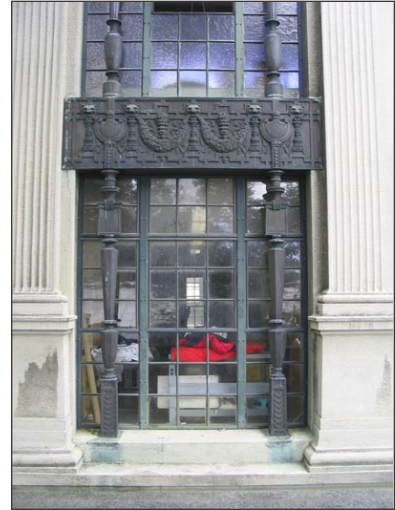
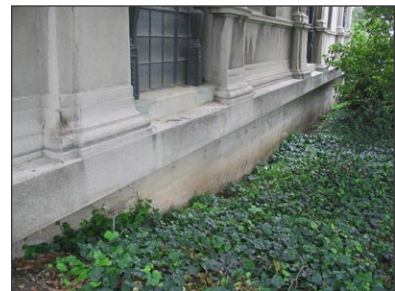
Window casements (top), 2005
Exposed foundations (bottom), 2005

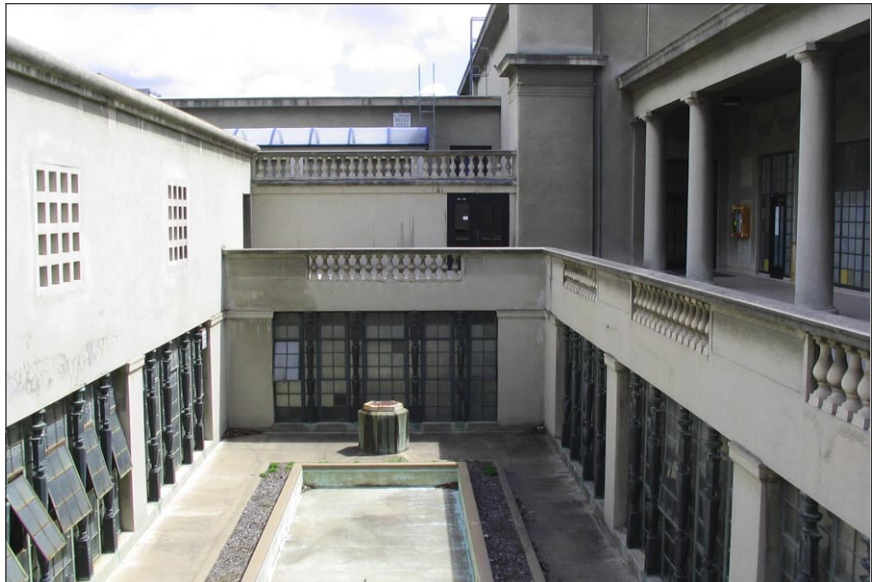
West courtyard, with reflecting pool now devoid of water and planters devoid of plants, 2005

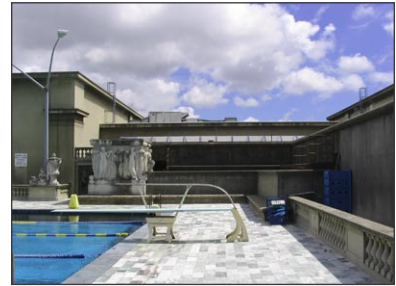
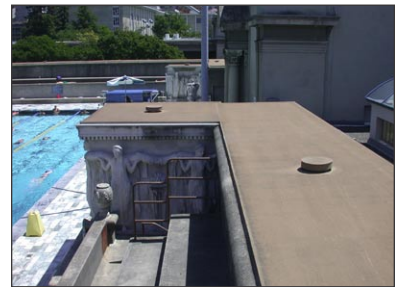
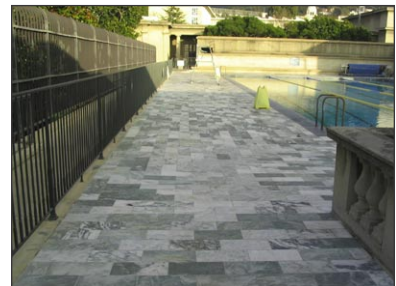
North pool, showing areas where planting has been removed at tree boxes and above bleachers, 2005

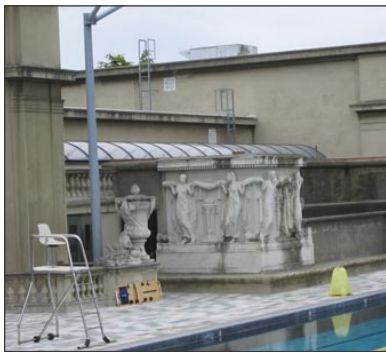
Sculptural tree boxes (now missing trees) and filled in planters at the north pool, 2005

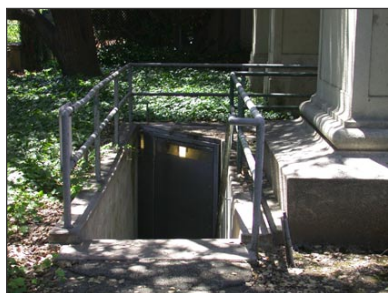
Stairs and entrance leading to Anthropology probably provides unwanted access of water

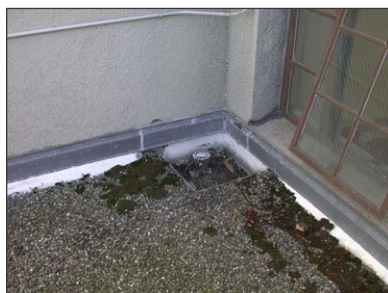
Roof drain showing signs of improper water retention.

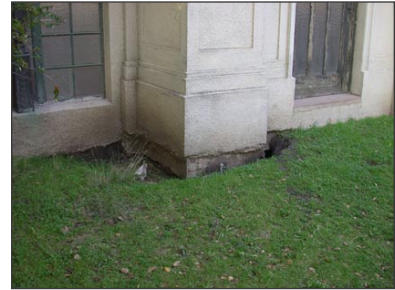
Soil erosion at foundation perimeter.

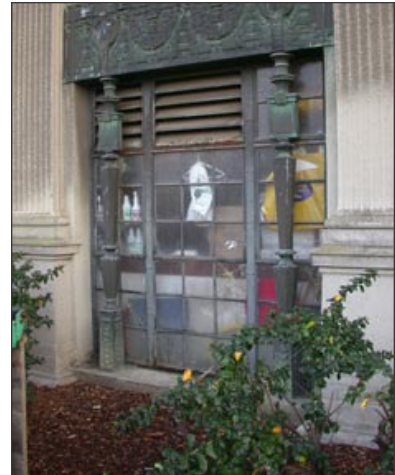
Prominent exterior window showing the storage of cleaning supplies.

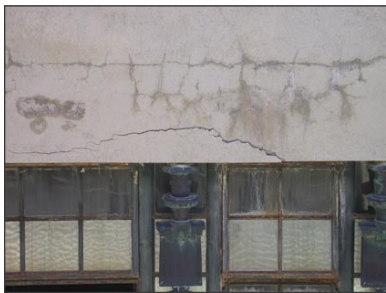
Telltale water damage, cracking and spalling to concrete substrate and stucco.

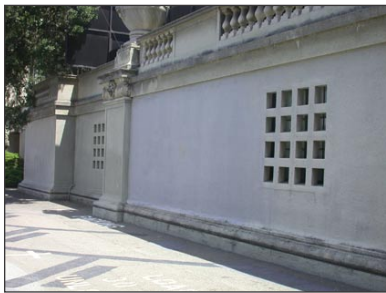
There is generally very little evidence of graffiti on the exterior, at least on the parging layer. The graffiti is most evident on the walls of the West Elevation at the Basement Level. The University of California, Berkeley, has clearly overpainted spray-on graffiti numerous times here. It is unknown if the University tried to remove the graffiti before choosing to overpaint it. Both the overpaint and the graffiti should be removed. If an anti-graffiti coating is warranted, it should be selected with the assistance of a conservation or preservation professional. As the parging layer covers nearly all of the original stucco, the degree to which the stucco sustained vandal damage is unclear.

Visually disturbing, graffiti-covering, paint.

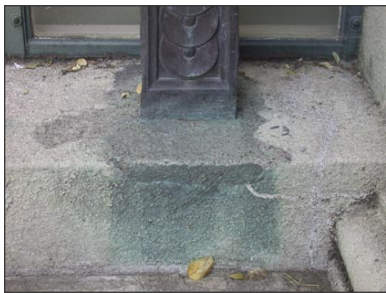
There is an extensive use of bronze sheeting in the form of window spandrels and spindles (see below) on the exterior of the building. The metal is exposed to a relatively harsh urban environment and withstands regular rain events. As a result, the bronze sheeting has corroded and deposits of copper salts are visible on its surface. When these corrosion products occur in significant amounts, they can flow in solution. [FIX] Visually, this manifests itself in green streaks and deposits on the building surface, which can be difficult to remove.

Copper salt migration into concrete.

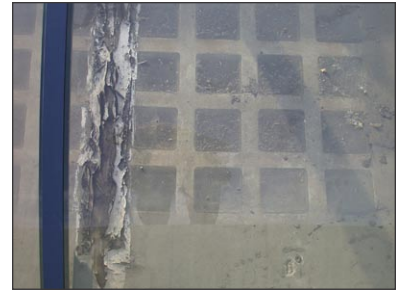
Soiling and joint failure at roof skylights.

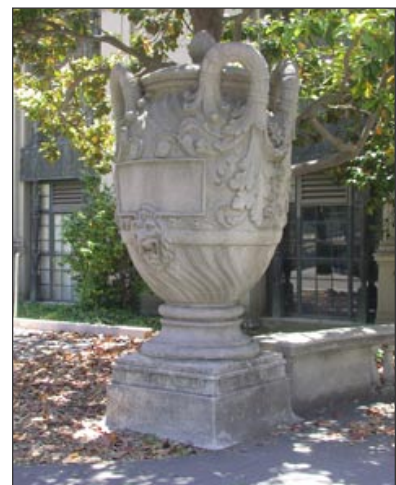
In 1977, all of the urns were removed and replaced with cast sand and resin replicas, perhaps because the originals were extensively deteriorated. Unfortunately, there is no documentation of the urns from that time, and the urns themselves are lost. Although different from the original urns in material composition, the replicas are true to Maybeck's design, and were most likely cast directly from the originals and refined to compensate for deterioration.

Replacement urns made of cast sand and resin with glass fiber reinforcements.

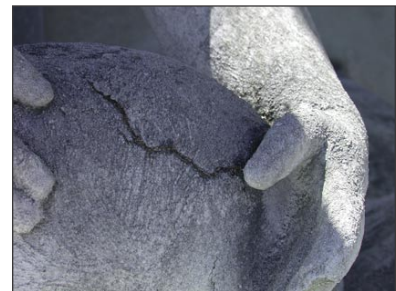
Opportunistic biological growth in, and cracking of, non-historic slurry coating.

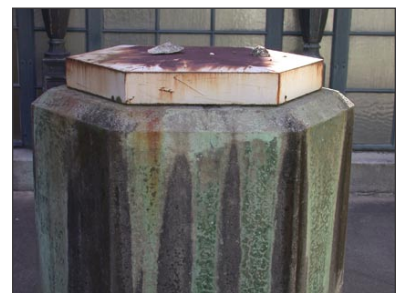
A geometric cast concrete pedestal is located at the south end of the East Courtyard on the Ground Floor. From limited historic documentation, it appears that the bronze sculpture originally installed on this pedestal was a female figure. It is currently missing. The pedestal is in poor condition, mainly due to copper corrosion deposits associated with the now-missing bronze sculpture, but also due to some biological growth. The iron alloy cover placed in lieu of the sculpture is severely corroded where the paint has been lost, and rust is migrating onto the pedestal.

Severely deteriorated sculpture pedestal.

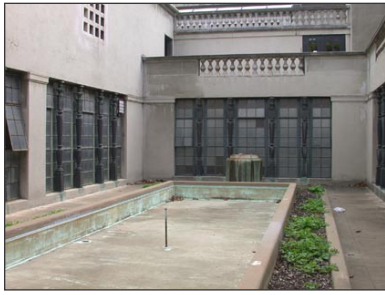
Neglected reflecting pool.

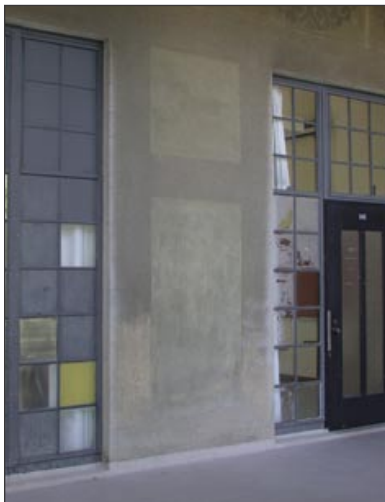
Textured concrete surface showing signs of aggressive and disfiguring maintenance.

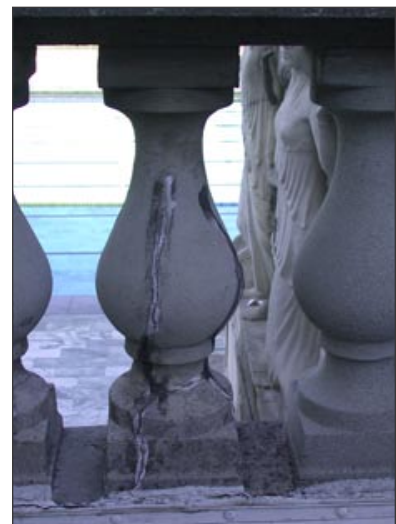
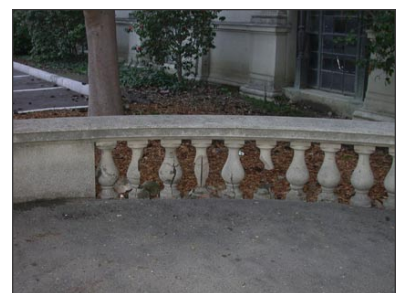
Over the years, some of the balusters were replaced, presumably because they had sustained enough damage to warrant replacement. These replacements differ from the original in the height of their plinths; the originals have 1 1/2 inch plinths while the replacements appear to have 3/4 inch plinths, with the difference in height compensated for with stucco applied after installation. There also were attempts to repair cracks in the balusters *in-situ*, but these were poorly executed and should be avoided in the future. As the structural failure of individual balusters poses a serious life-safety risk, a conservation or preservation consultant should be consulted to advise upon structurally sound and visually harmonious means to repair these elements.

Poorly repaired (top) and damaged balusters (bottom).

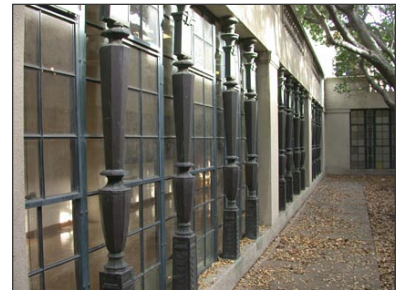
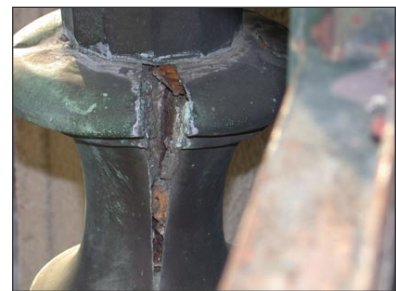
Copper alloy spindles (colonnettes), top. Cracked bronze spindle sheathing exposing internal fill material, bottom.

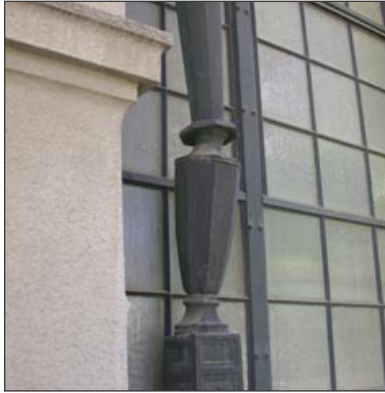
Bent window spindle, probably caused by climbing, top.

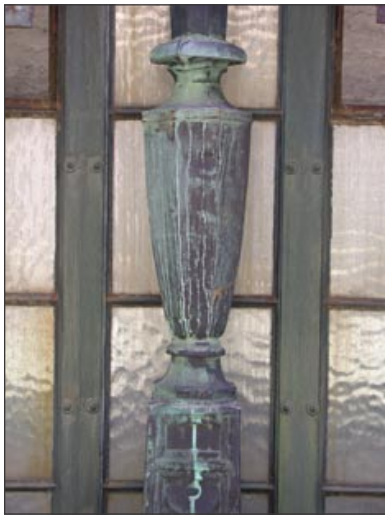
Surface corrosion and soiling to metal spandrel and spindle.

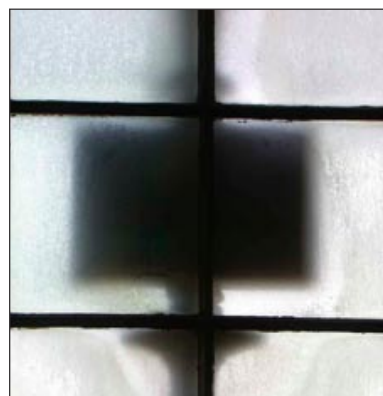
Polycarbonate replacement glazing.

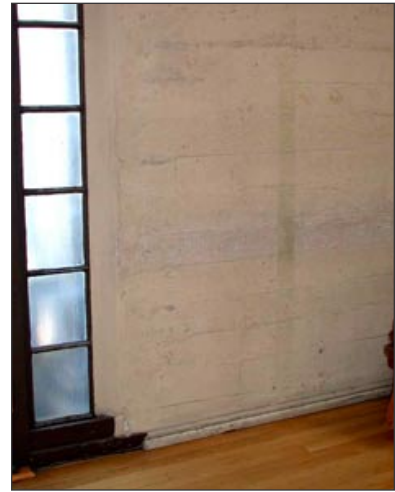
Physical and visual evidence of original decorative paint scheme (buried under layers of overpaint).

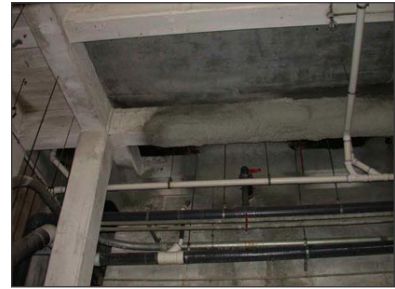
Insensitive shotcrete repairs to damaged concrete

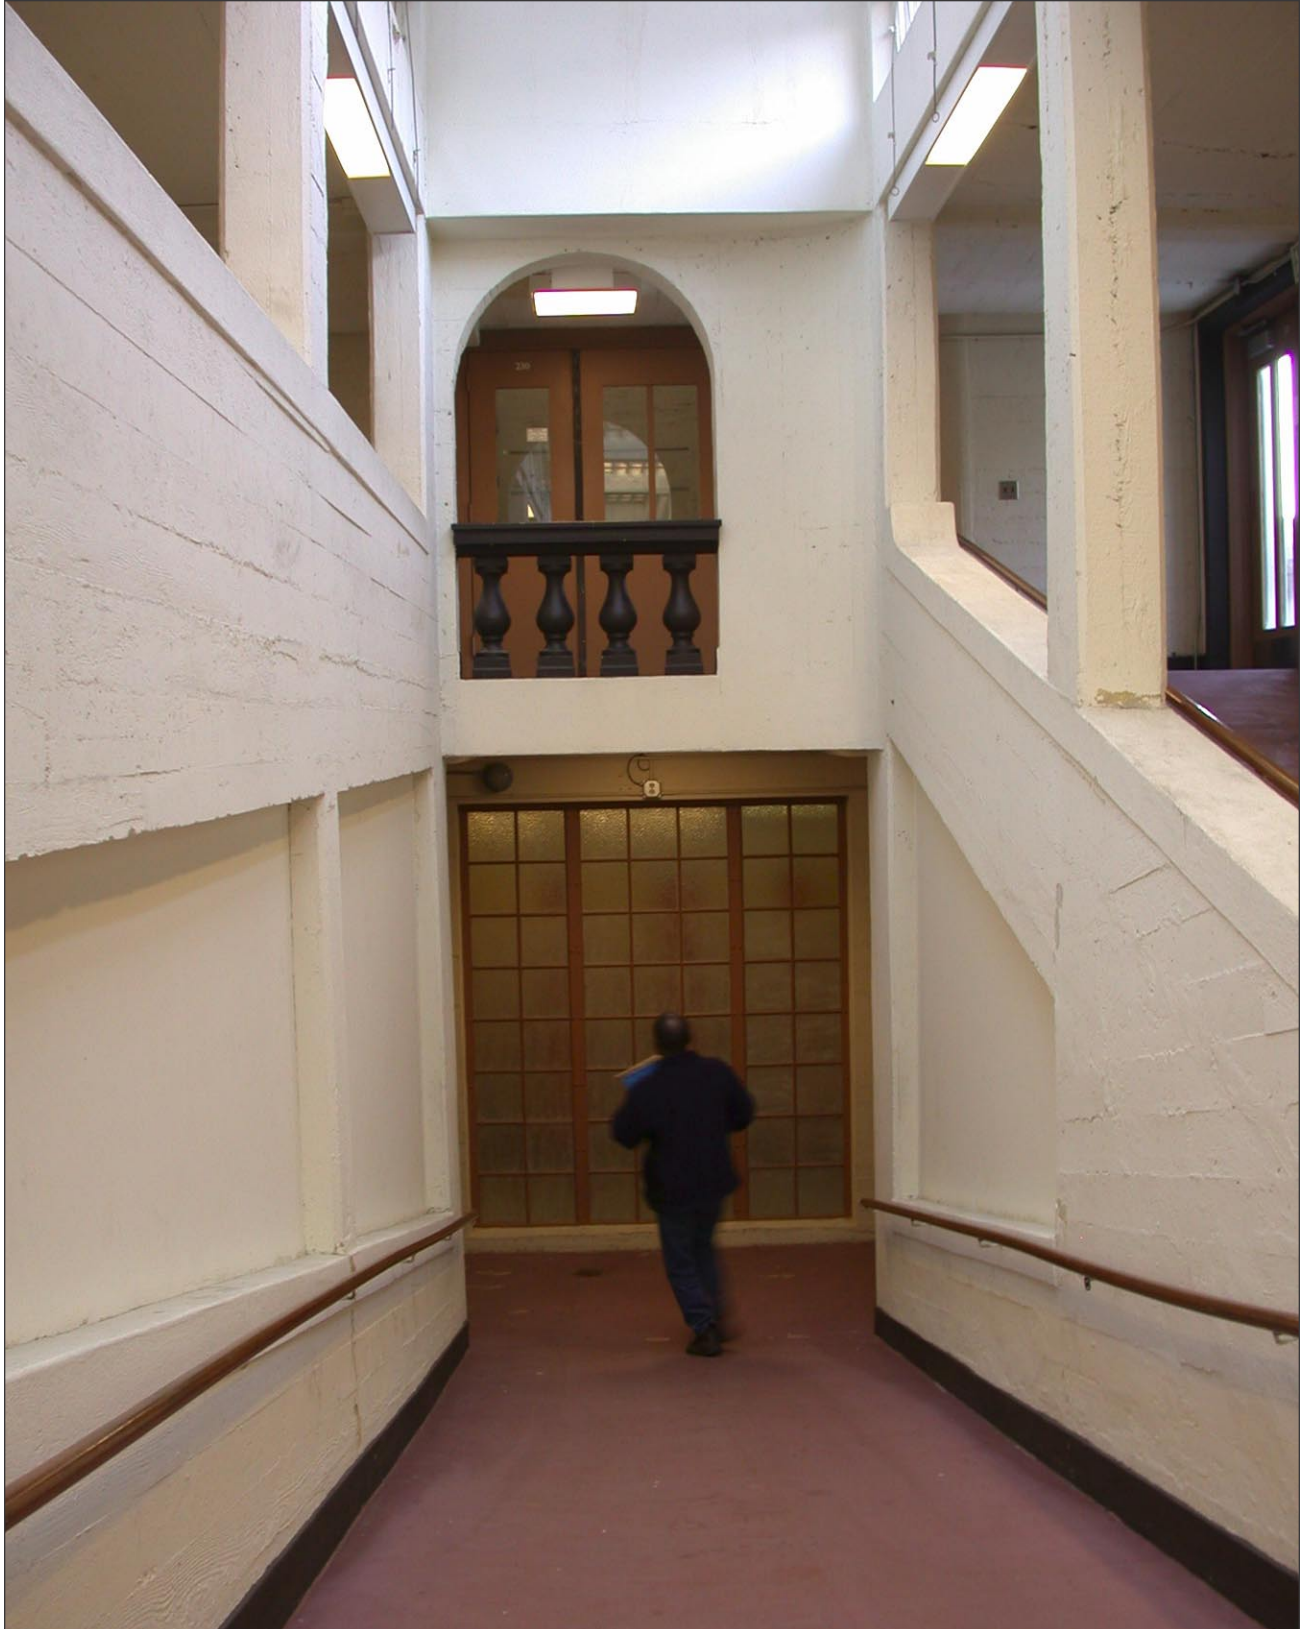
The ramps do not provide adequate exit capacity, and are steeper than allowed by current codes
