September 2005

HEARST MEMORIAL GYMNASIUM

Historic Structure Report

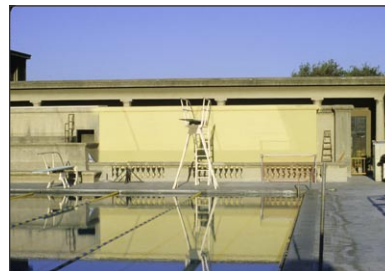
New concrete masonry wall at the west elevation of the North Pool area before paint color adjustment to match historic walls.

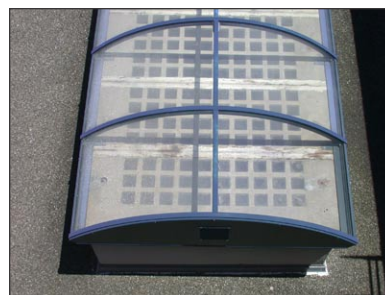
Polycarbonate acrylic skylight covers, 2005.

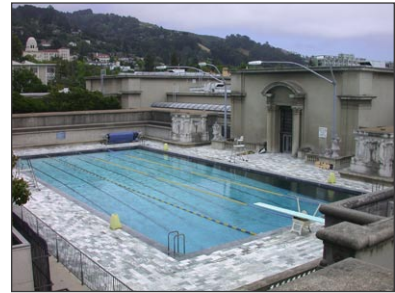
North pool, 2005

The pool and deck is the most significant outdoor space in the building. The pool deck was originally intended to be part of a larger plaza which includes the space surrounding the adjacent auditorium. Since that was not built, there is now a pastoral view towards the campanile and the hills. The original design intent, with planting in boxes above the bleachers, and shrubs in the sculptural shrub boxes, was to allow swimmers to be surrounded by greenery, with only the central pavilion visible from the pool itself. The removal of all planting and other modifications has significantly impacted the historic character of the pool area.

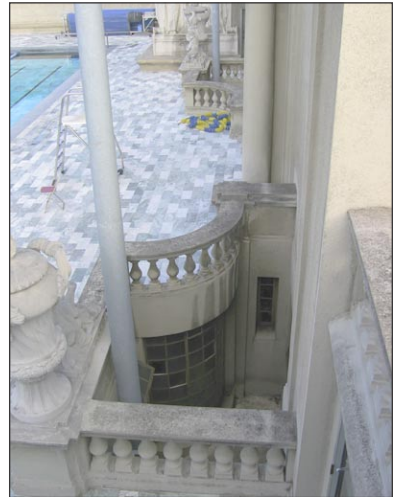
Light wells at the north pool, 2005

These small wells with convex windows brought light into the deepest part of the ground floor, adjacent to the original entrance to the women's shower room. Many of the windows are now covered on the inside, so the wells are no longer apparent on the ground floor. The large light fixtures attached to the sides of these wells have a negative impact on their historic character.

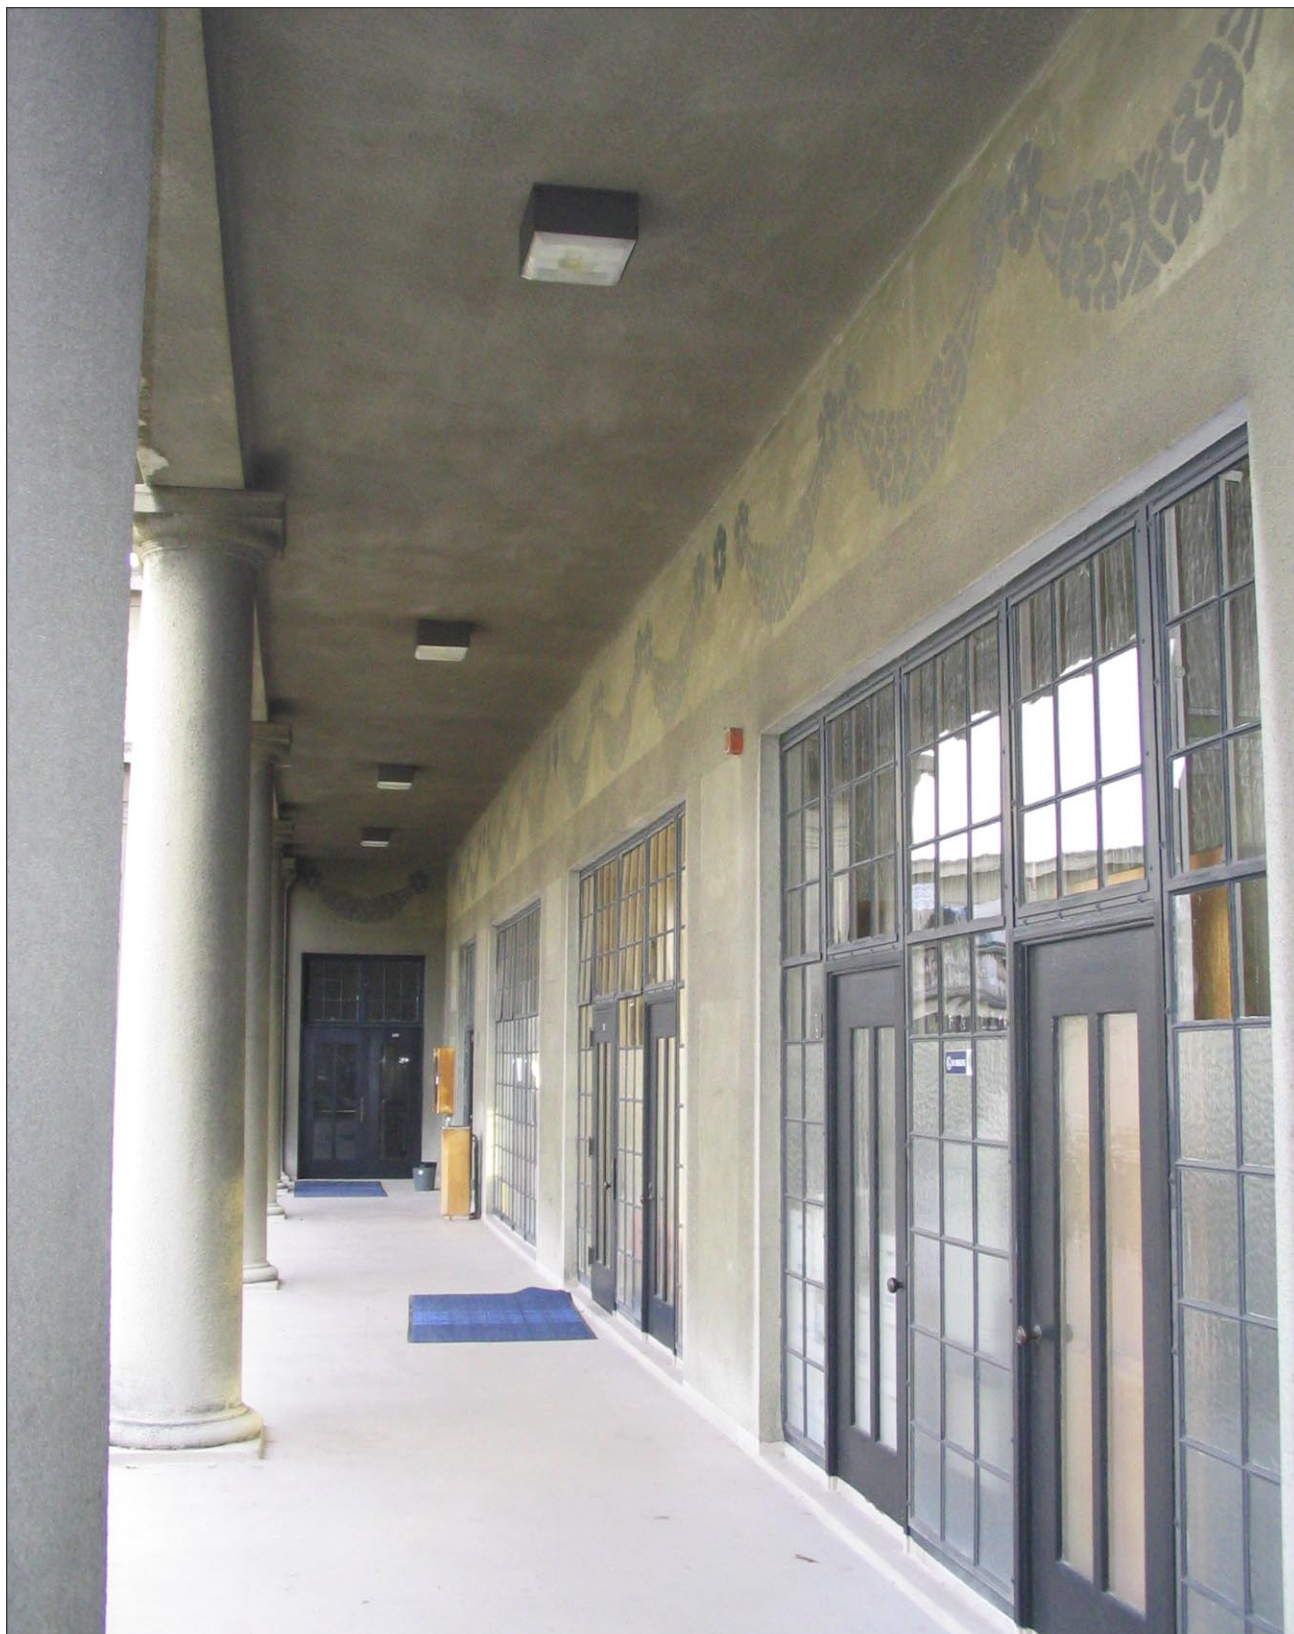
West collonnade, 2005

The colonnades provided protection from the weather for building circulation on the main floor, and also provided shade for adjacent classrooms. They overlook the courtyards. The replacement of the scored patterned concrete flooring with an un-patterned elastomeric membrane has obscured some of the original character of these spaces.

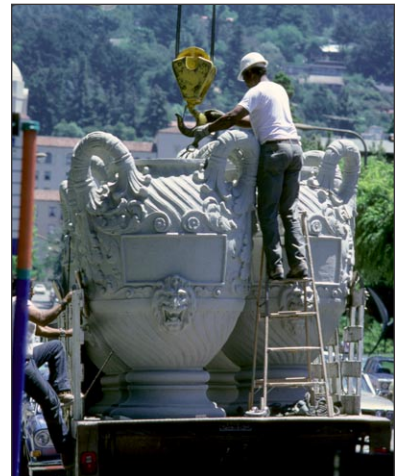
Replacement urns

Parging on Original Stucco (all elevations and levels)
Parking Lot Lights at North Pool (M)
CMU Wall at North Pool (M)
Security Fencing and Razor Wire (M) (G)
Polycarbonate Glazing (M) (G)
Non-Skid Safety Surfaces (M, G)
Stairway and Elevator to Anthropology (M, G)
Dumpsters (G)
North Elevator Enclosure, Entrance and Canopy (G) (M)
Poor Condition of Character-Defining Elements

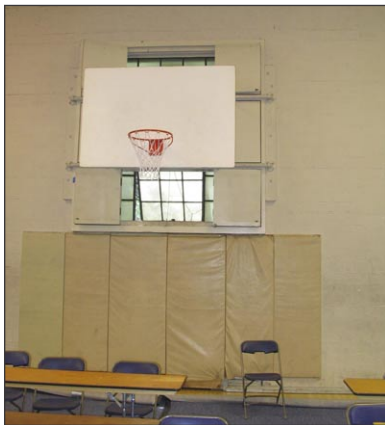
Shutters and backboard obscure windows, west gymnasium, 2005

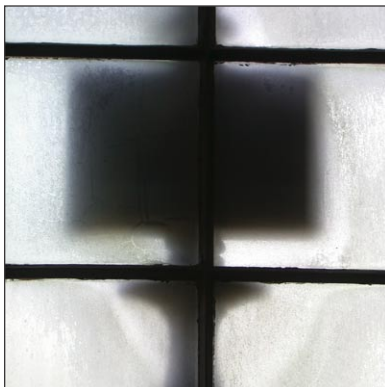
Polycarbonate glazing

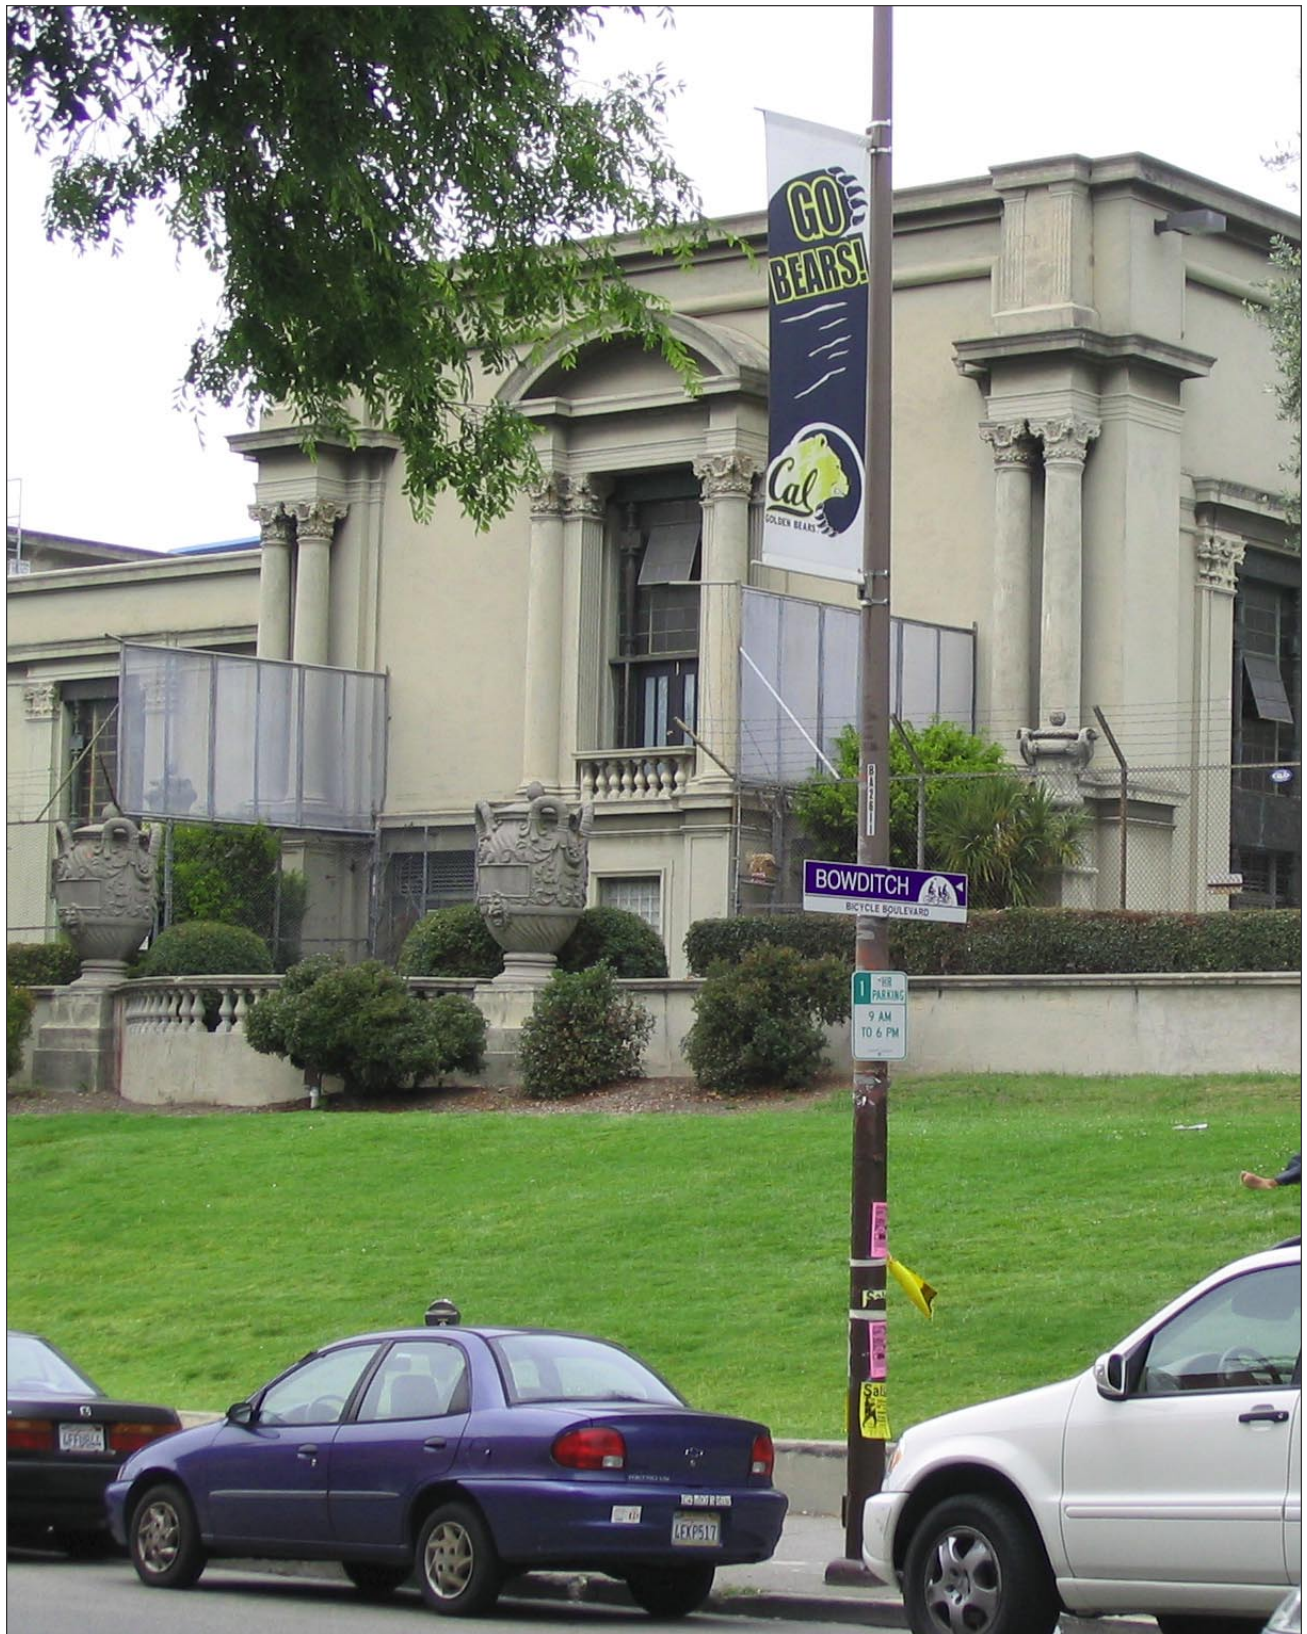
Security fencing obscures the south elevation, 2005

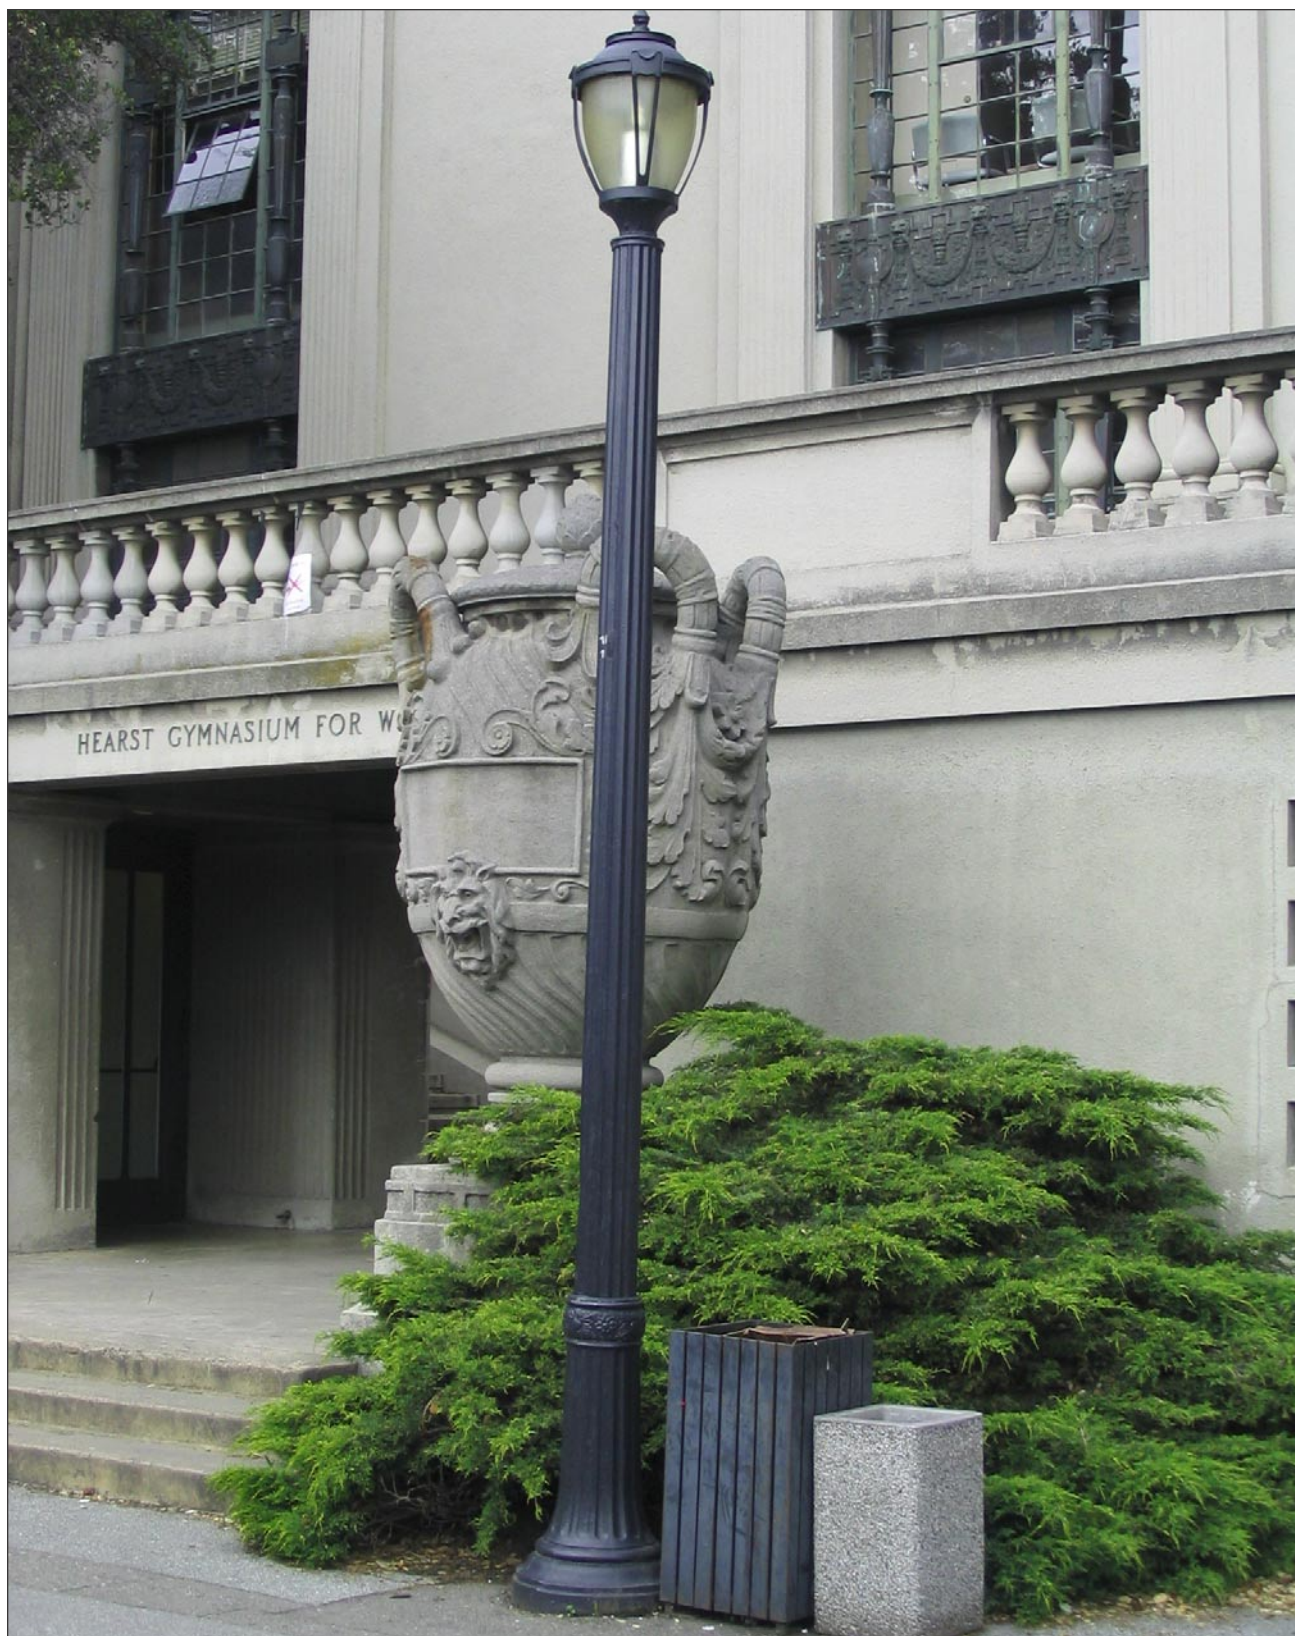
West entry and terrace, 2005

The concrete paving and scoring pattern on the ground floor terrace that lies over the main western entry appear to be original. Minor cracking is evident on the surface. Balustrades in this area are in good condition, but are too low to satisfy current codes.

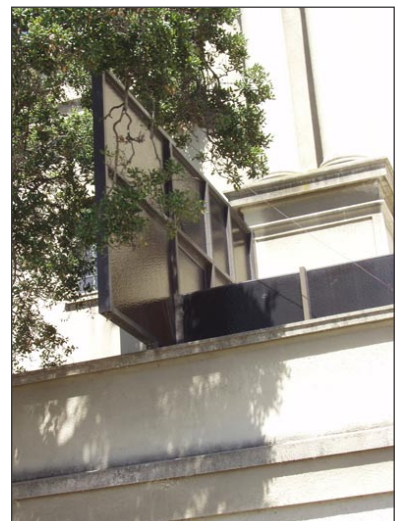
The addition of the terrace level fencing and parking spaces on asphalt immediately adjacent to the building negatively affect the integrity and are elements that conflict with the historical view of this façade. Light poles, trash receptacles and ash urns clutter the entry areas.

Fencing at west terrace, 2005

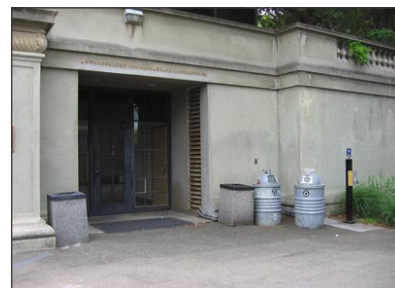
Garbage cans adjacent to entry, 2005

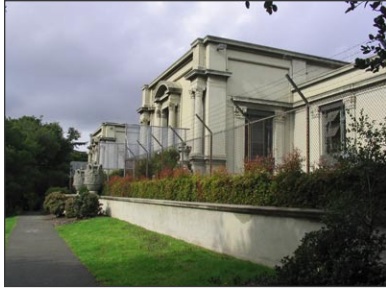
The landscape is poorly maintained adjacent to the central pavilion, south, 2005

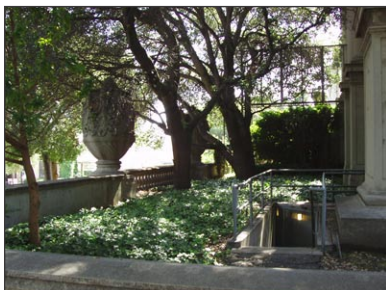
The lawn at the southeast corner is now shady and overgrown, 2005

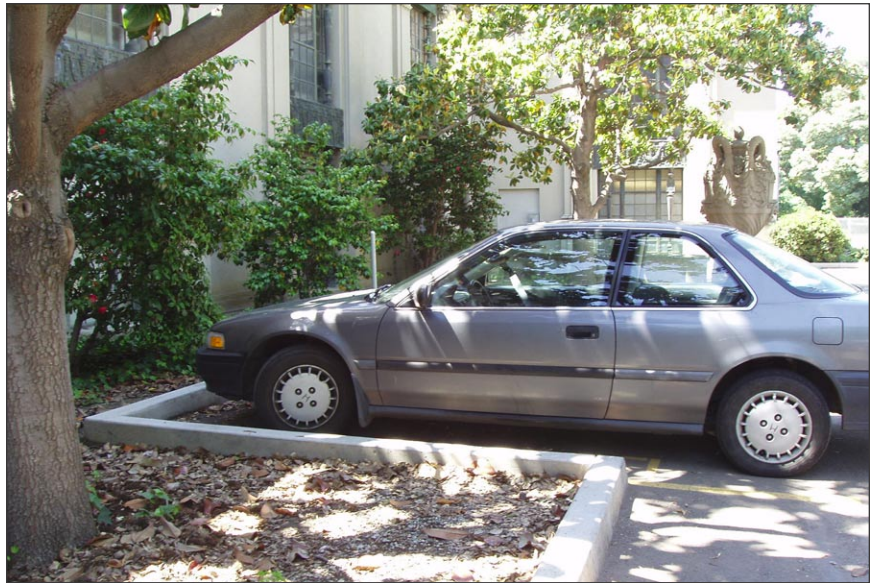
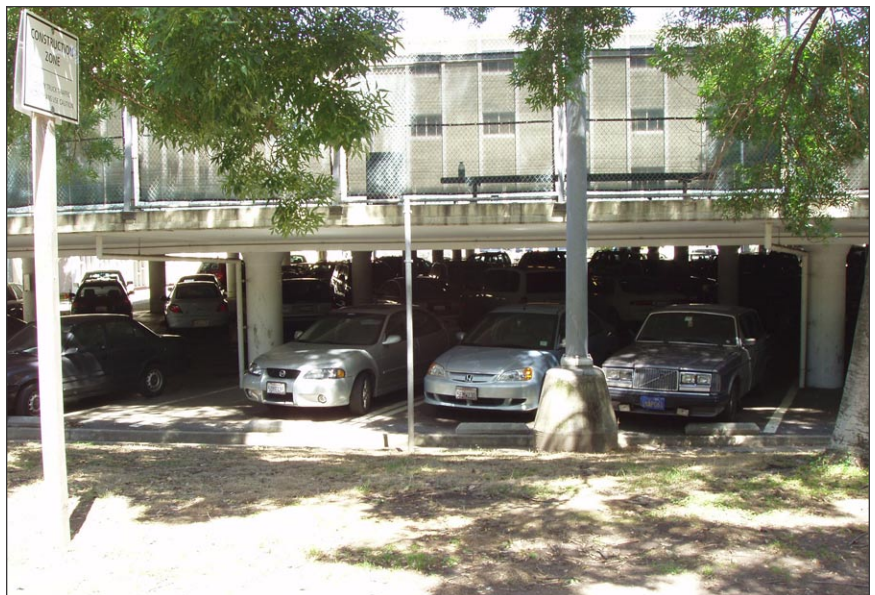
Light poles, trash receptacles, parking spaces and ash urns clutter the entry areas.

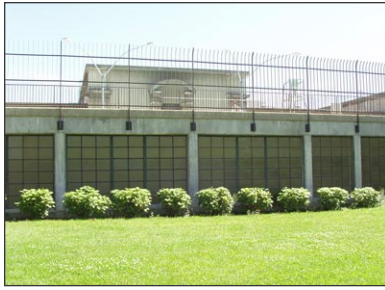
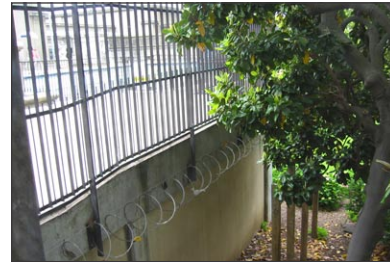
Security fencing along the north elevation, above the north corridor, 2005

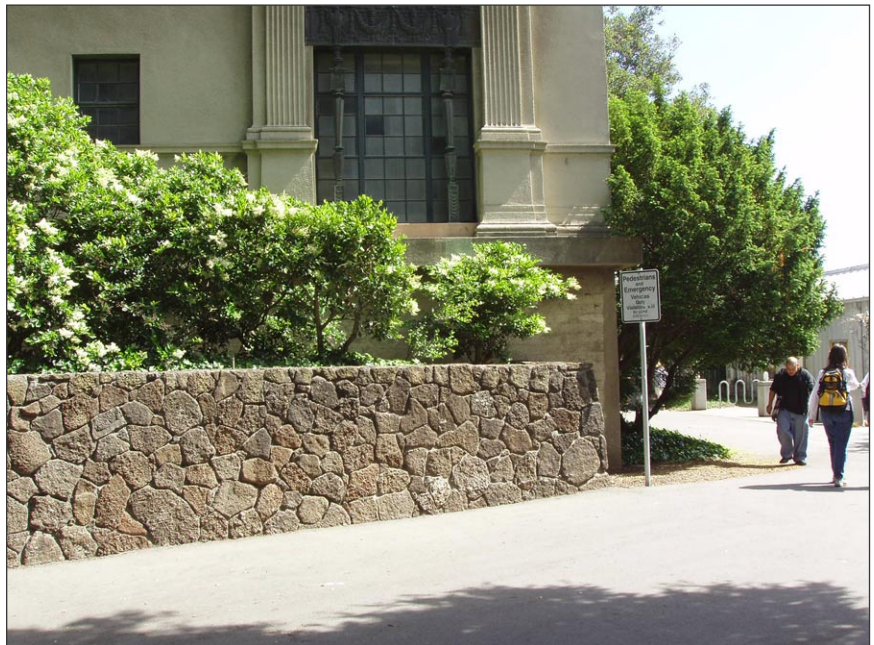
With the construction of Barrows Hall, the pedestrian connection around the northwest corner of the gym was altered. The Camphor trees in this area are likely to be original while the rock retaining wall, added later by Thomas Church, is out of character with the materials of the gymnasium.

Retaining wall between Hearst and Barrows Hall, 2005

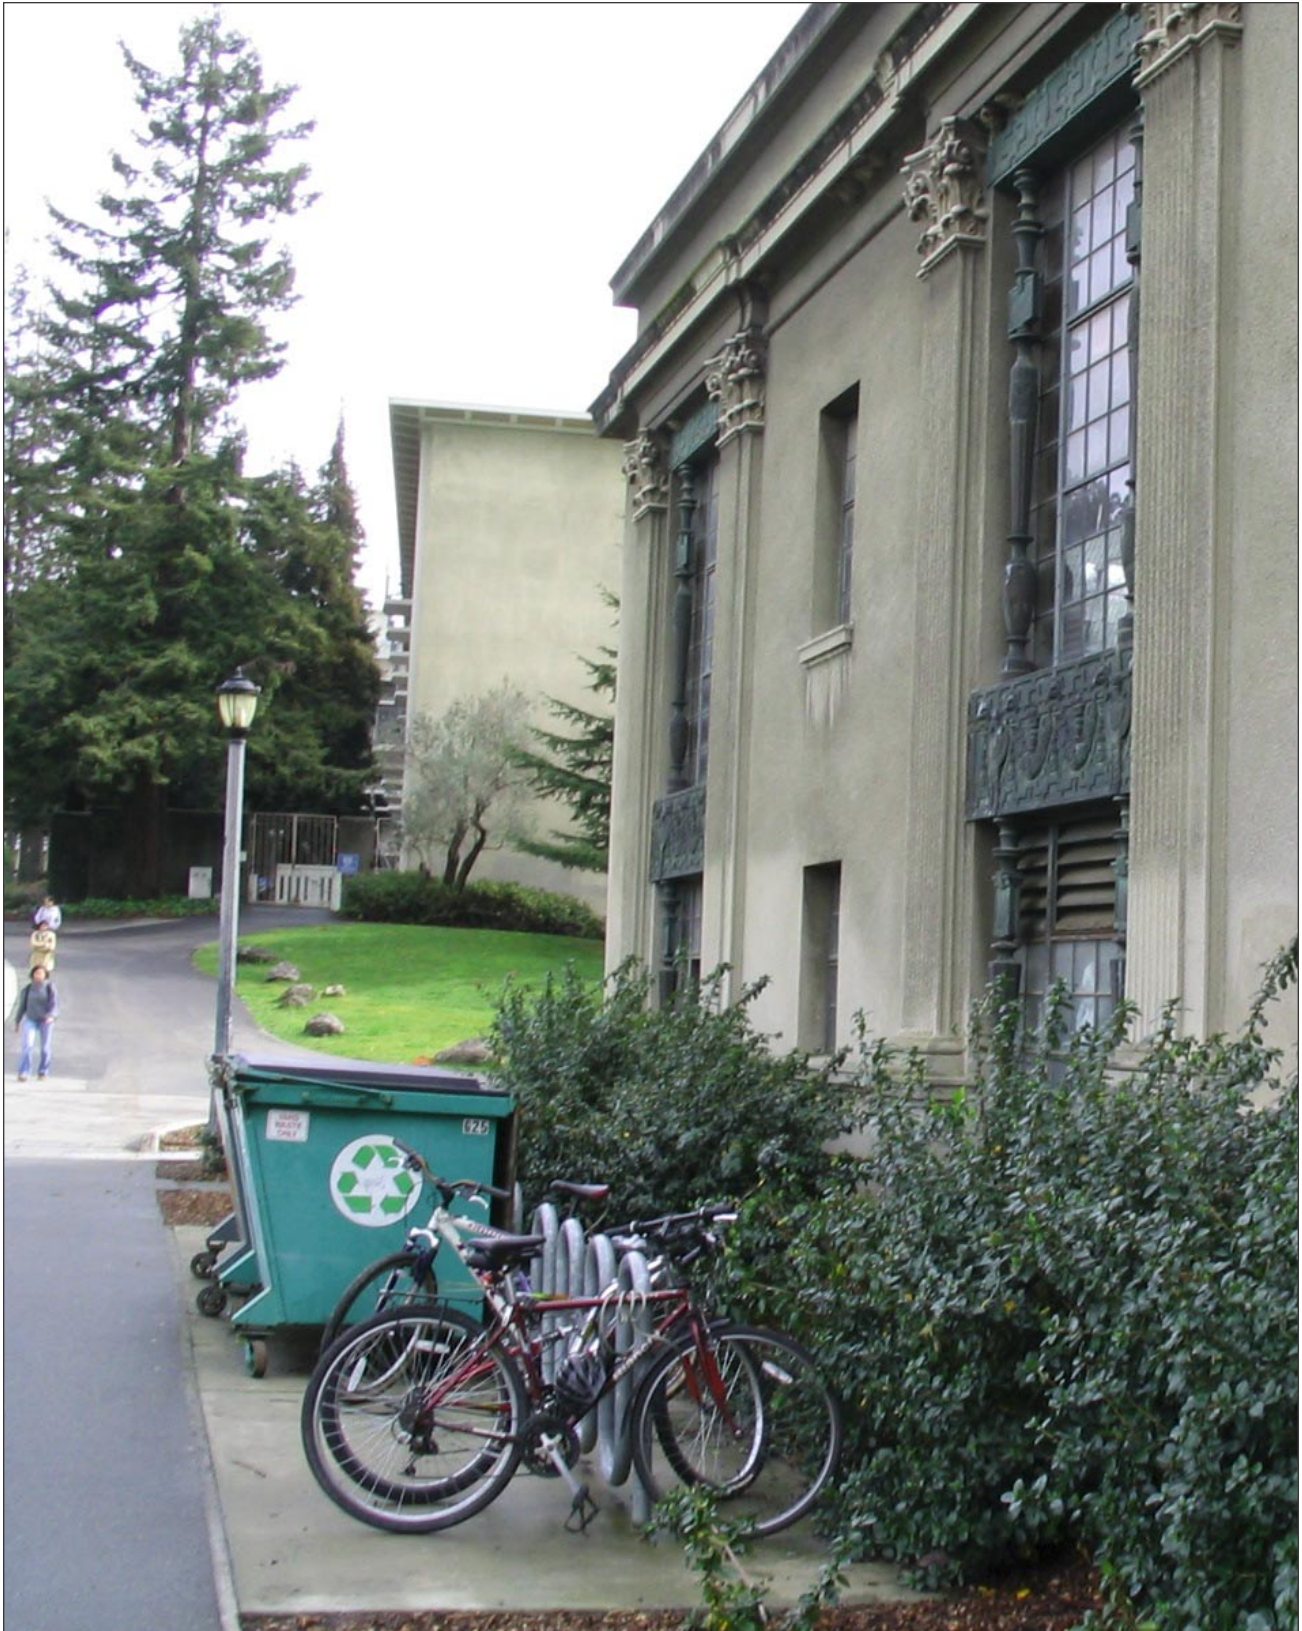
Dumpsters and bike racks clutter the areas to the north of the building, 2005

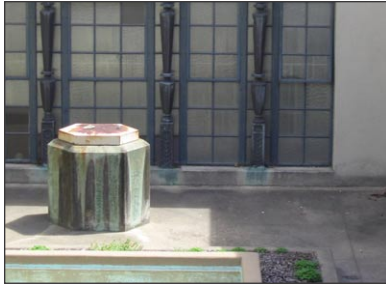
West courtyard, with empty sculpture base, 2005

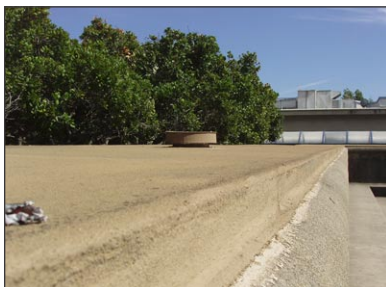
Sculptural tree boxes (now missing trees) and filled in planters at the north pool, 2005

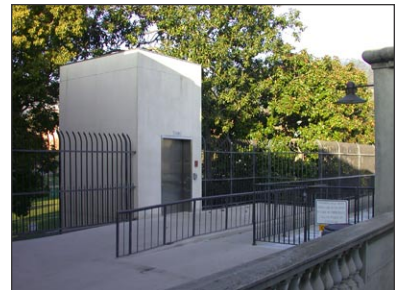
Visually obtrusive north elevator.

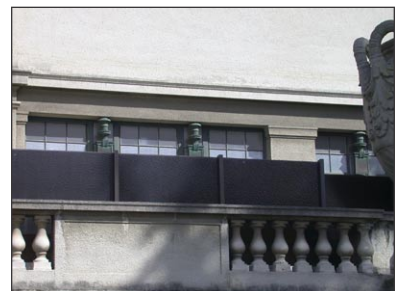
Visually obtrusive security barriers.

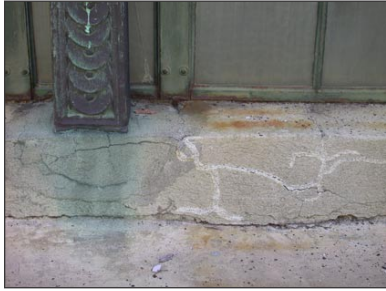
Cracked concrete window footing (with both copper and iron staining).

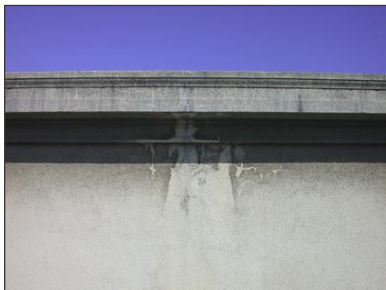
Water intrusion to the parapet showing signs of salts and soil migration.

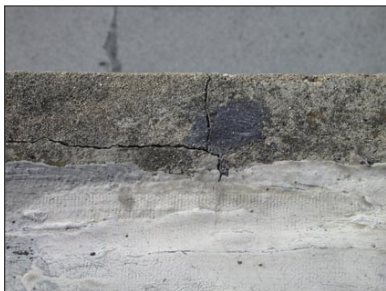
Cracking of the concrete parapet.

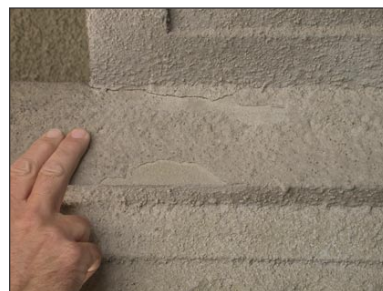
The parging also obscures conditions such as damaging ferric reinforcement corrosion, spalling or other structural instability in the concrete. Being cementitious and most likely acrylic-amended, the parging is much harder than the original stucco, and may in fact be causing deterioration to the softer original material behind it. Water, as well as water laden with soluble salts can easily be trapped behind the parging, a condition that can result in it cracking or spalling over time. A closer study of the parging should identify whether soluble salts are in fact present, and whether they are damaging the parging layer or the original stucco behind it. The cementitious layer shows differential soiling, with some areas where fast moving water has removed the dirt appearing significantly cleaner than those with little water exposure.

Losses to a non-historic parging layer.

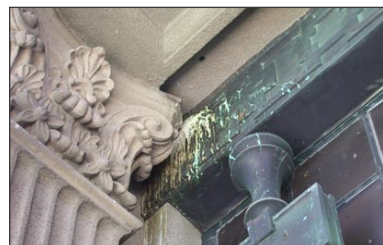
Active and inactive mud swallow nests are found at many locations under the eaves of the building. While the nests do not pose a physical problem to the building *per se* they are an unintended visual addition. Significant deposits of bird guano are present directly under the nests. Guano is both visually disturbing, but more importantly, is chemically damaging to both the cementitious and metal surfaces present on the building exterior.

Mud-built swallows' nest (active), top. Pigeon guano deposits on metal-clad spandrels, bottom.

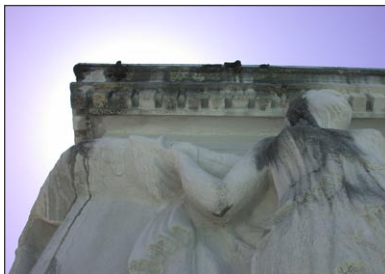
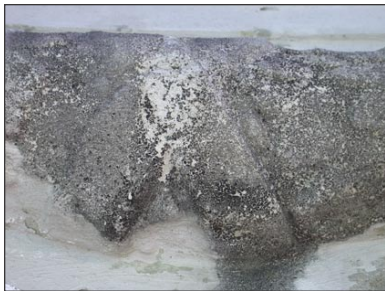
Soiling, moss and mold on tree boxes.

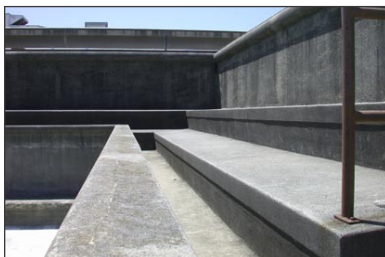
Hedge boxes, bleachers and benches.

contain hedges; these were most likely removed because they began to leak water. The tops of the boxes have been covered with wood enclosures. Generally, all three elements are in fairly good condition with the exception of some surface weathering, and occasional cracks along sub-surface reinforcement lines.

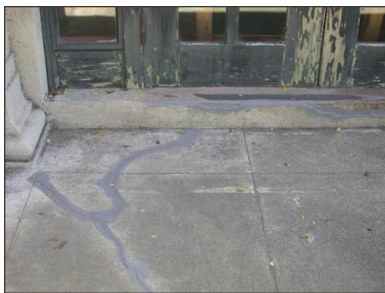
The cast concrete reflecting pond located in West Courtyard on the Ground Floor Level is in very poor condition. The pond basin has been drained, presumably due to the leaking of water from the pond into the Mechanical Room and Filter Ponds below. There are serious, potentially structural cracks in the basin and in the cast concrete perimeter curbs. The pond basin shows evidence of multiple layers of aqua colored paint. The corroded metal pipe currently serving as the fountainhead does not appear to be original. The design of the original fountainhead is as yet unknown. The plantings around the perimeter of the pool are missing.

Badly executed crack repairs.

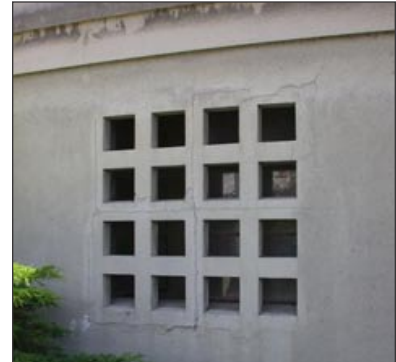
There are cast concrete grilles in several locations on the exterior of the building—three on the Basement Level of the West Elevation, and three on the Main Floor walls above the East and West Courtyards. Several of the grilles on the West Elevation are in poor condition, having cracked and been displaced as a result of shifting loads in the building. The grilles in the West Courtyard are replacements made during 1970s seismic upgrades to the courtyard, and were installed without sensitivity to the surrounding historic materials. The East Courtyard grilles are original and are in good condition as they are fairly well protected from the elements. The original grilles on the North Elevation were removed when the North Elevator was installed.

Cast concrete window grilles.

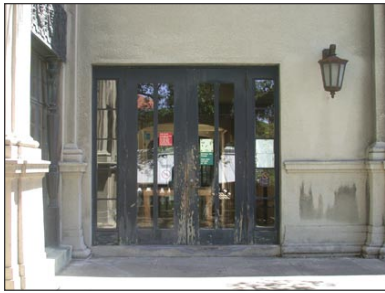
Main Entry doors.

Whereas most of the doors in the interior of the building have been replaced, some of the doors on the exterior appear to be original. The Main Entry doors to the building, (West Entrance, Ground Level) are original with original hardware. The doors are in fair to poor condition, suffering from both mechanical damage and damage due to weather exposure. In other parts of the building, many doors and most door hardware have been replaced as dictated by safety requirements, or by levels of damage to original elements. Glass lights on doors are largely replacements. In areas where original glass exists, it is primarily the prismatic glass.

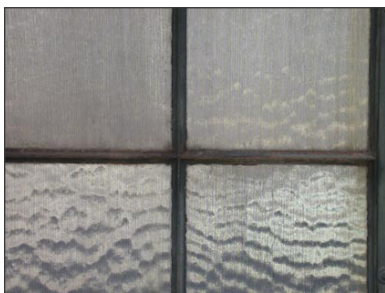
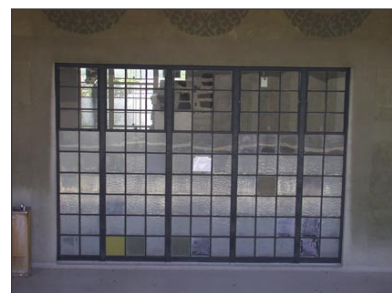
Original prism glass, top.
Casement window showing variety of original and replacement panes, bottom.

As previously discussed, the existing large-scale replacement of historic window glass in the building is a character-inhibiting feature. In particular, the use of polycarbonate sheeting, and solar films on top of the polycarbonate sheeting is not in keeping with the original architectural design.

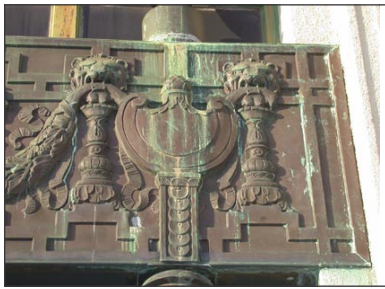
Surface corrosion and soiling to metal spandrel and spindle.

The spindles are hollow metal columns filled with a scrap concrete and debris mix known as breeze. Spindles are attached to the concrete window surrounds in front of the windows. As with the spandrels, the spindles are also in fair condition considering their extended exposure to the elements and their vulnerability to vandalism. The spindles located at levels of human access have sustained some damage, most likely from climbing. Otherwise, there appears to be little or no vandalism damage. Only two of the spindles, on the South Elevation of the West Gymnasium, are missing. The corrosion of metal surfaces is the most obvious condition of concern for the spindles; not only is the bronze metal susceptible to corrosion, but the breeze used to fill the spindles can contain ferric fragments that also corrode and cause cracking to the copper alloy surface as they expand. Copper staining is found on both the bronze, as well as on the concrete and stucco surfaces of the building.

1.3	Restore bronze window surrounds, spandrels and spindles, per Window Survey.			
1.4	Refurbish or replace window casements, window glass and hardware, per the Window Survey.

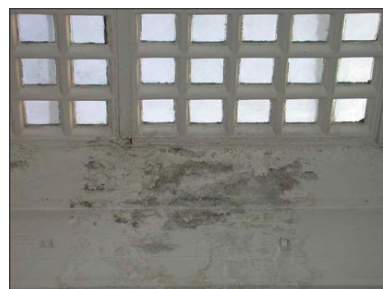
Water intrusion at skylighted clerestory showing paint delamination and salt efflorescence.

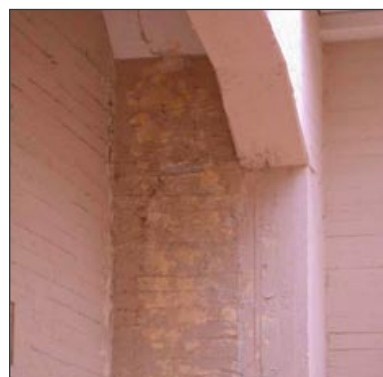
Severe water intrusion at gymnasium corner ducts (internal leader system).

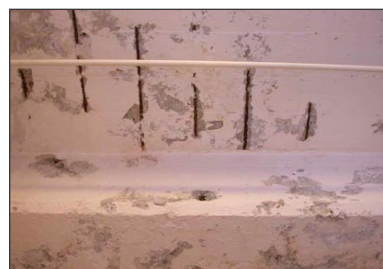
Corrosion of ferric reinforcements causing jacking or spalling of surface concrete.

Water intrusion from leaking roofs and exterior decking pools into the Ground Floor and Basement of the building has reached the ferric reinforcements of the concrete, causing them to rust and expand, and in turn causing the concrete to pop off in fragments – a deterioration mechanism known as spalling.

- Mitigate corrosion to the existing reinforcing by repairing corroded areas and improving ventilation to pool mechanical spaces to reduce the concentration of destructive chlorine vapors.

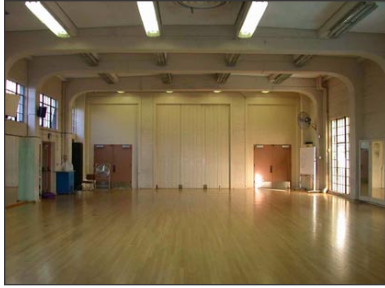
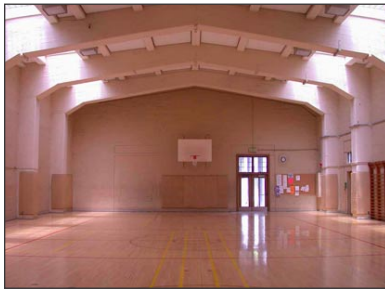
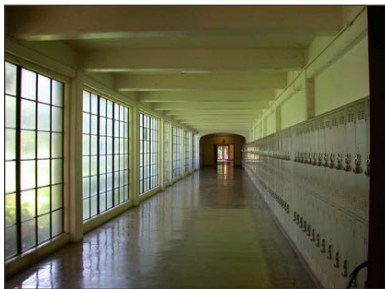
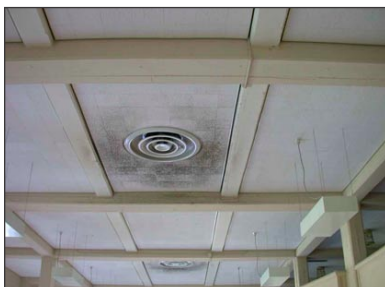
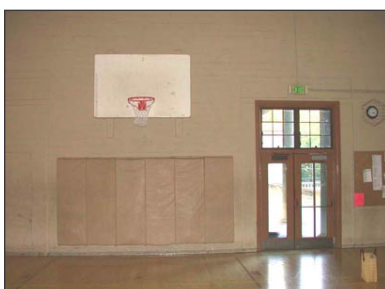
Non-historically compatible architectural infills and additions.

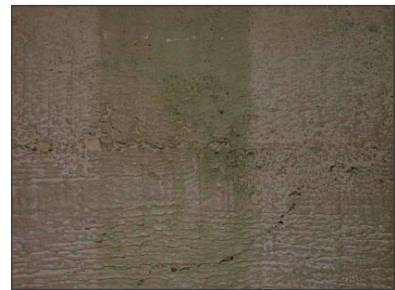
Historic photographs show evidence for two possible decorative painting schemes in the Central and West Gymnasia. The first scheme consists of architectural elements painted onto the concrete walls creating the appearance of gothic arches and window detailing – specifically around the south window of the Central Gymnasium and on the north wall of the West Gymnasium. This surface treatment is consistent with the Maybeck and Morgan drawings found in the CED archives. Archival drawings, if followed exactly, also show the use of bright colors in these paint schemes. Today, the decorative paints are still visible under the multiple layers of overpaint (in a condition referred to as ghosting) although their actual colors and patterns will be unknown until a study is conducted.

Detail of original decorative paint evidence.

3.6	Carefully remove overpaint from the Central Gymnasium walls, ceiling and structural elements, per the Paint and Color Study.		
3.7	Remove overpaint from the East Gymnasium walls, ceiling and structural elements, after the Paint and Color Study is completed.

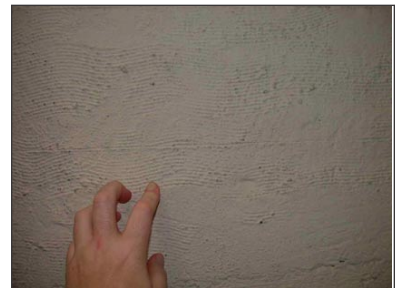
The combed decorative mortar is in excellent condition, with no delamination of the mortar from its concrete substrate visible. However, the exact condition cannot be seen until some of the overpaint is removed. The mortar should not be cleaned without the input of a conservation or preservation professional. The mortar should not be overpainted again.

Detail of decoratively combed wall surfaces.

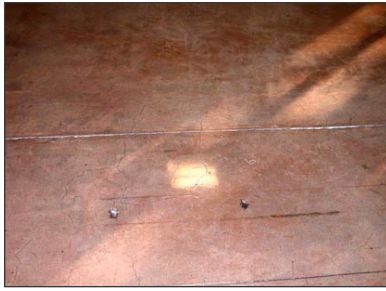
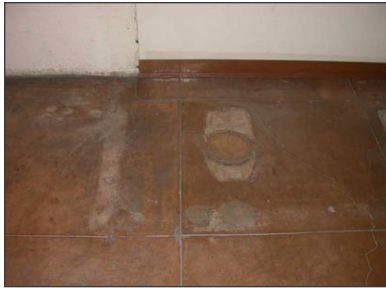
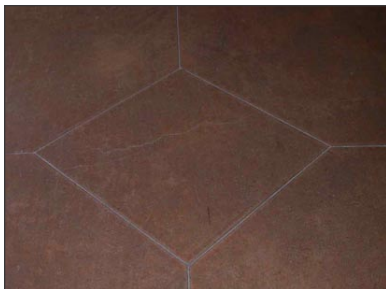
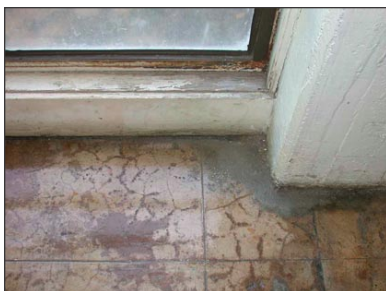
Integrally colored concrete floors with evidence of architectural changes and of water damage to surface coatings.

The floors throughout the building are generally in good condition. They show minimal damage from typical wear and tear, which is remarkable given the age of the building and its programming demands. However, the floors have suffered potentially significant damage from some of the architectural changes made to the building (i.e., they have been drilled into, covered over, safety strips applied, etc.). Some general cracking from building movement and settlement and other cracks from the contraction of the concrete (spider cracking) due to non-ideal mixing or drying techniques are intermittent throughout the interior. These do not pose serious preservation concerns but should be monitored. If the concrete floors begin to powder or crumble, a conservation or preservation professional should be consulted for treatment.

The floors have been covered with coatings over the years – probably acrylic, wax, polyurethane or a combination of any of these materials. On one hand, these coatings have protected the floors from abrasive wear and tear. On the other hand, the coatings have also darkened the floors, trapped dirt and imparted a glossy surface that likely was not originally intended. Another concern is the blanching of the coating when water or air creates a space between the surface of the floor and the underside of the coating resulting in a hazy appearance (similar to the white ring left on a table when a wet glass has been left on it too long).

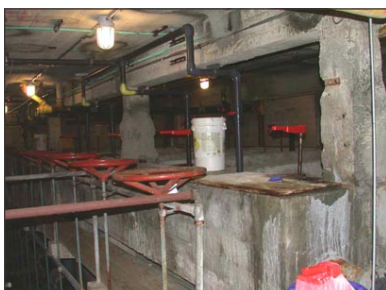
Shotcrete repairs to damaged concrete

In the late 1970s, in an effort to repair the spalling, shotcrete, a hard and usually sulfate-containing (and acrylic modified) concrete was used as a patching material. According to the architectural plans, approximately 106 cubic feet of the interior – mostly around the substructure of the pools, the North Pool in particular – were repaired with shotcrete. While these repairs appear to be in good condition, they may accelerate deterioration to the original concrete behind them as they are probably harder and less porous

than the historic concrete. Generally speaking, when patching historic materials, the fill material should be softer and more porous than the surrounding historic materials since the softer of the two materials will always deteriorate first. Although a seemingly minor point, the repairs are not in keeping with the surfaces of the building interior. During the 1970s repair campaign, approximately 253 linear feet of crack repair was completed using epoxy grouts and adhesives. At the time, the engineering firm assessing these conditions estimated that another 3000 linear feet of epoxy repairs to cracks might be needed.

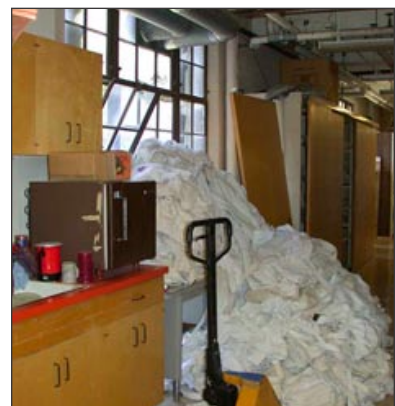
The current use of the laundry room poses potential hazards for one or more of its casement windows. Laundry is piled against the windows in such a way as to be both potentially physically damaging as well as visually disturbing. New collection areas placed away from the windows should be designated.

Inappropriate use of window as a laundry repository

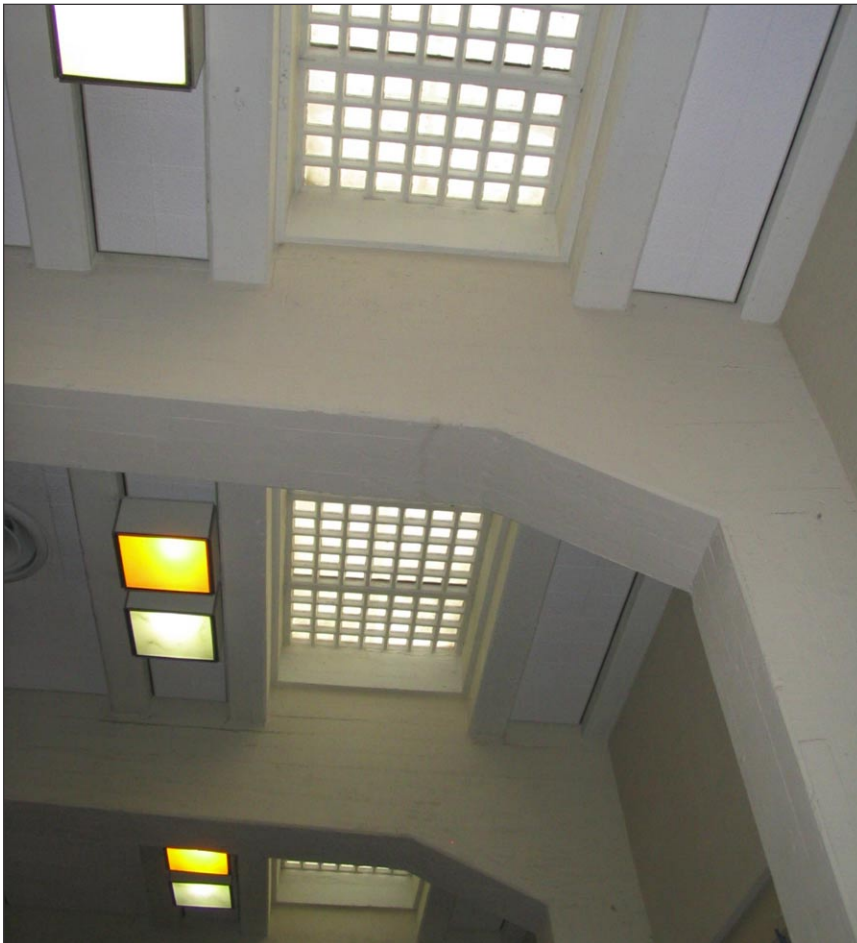
Strengthening the gymnasium skylights in a sensitive manner is one of the most challenging aspects of the structural upgrading

- Replace substantial portions of the building's roofing due to corrective structural work at the roof level.
- Remove non-historic acrylic domes covering the existing skylights, and rehabilitate the existing glass block skylights. This work is required due to the disturbance from the extensive structural reinforcement that will be installed adjacent to the skylights.
