September 2005

HEARST MEMORIAL GYMNASIUM

Historic Structure Report

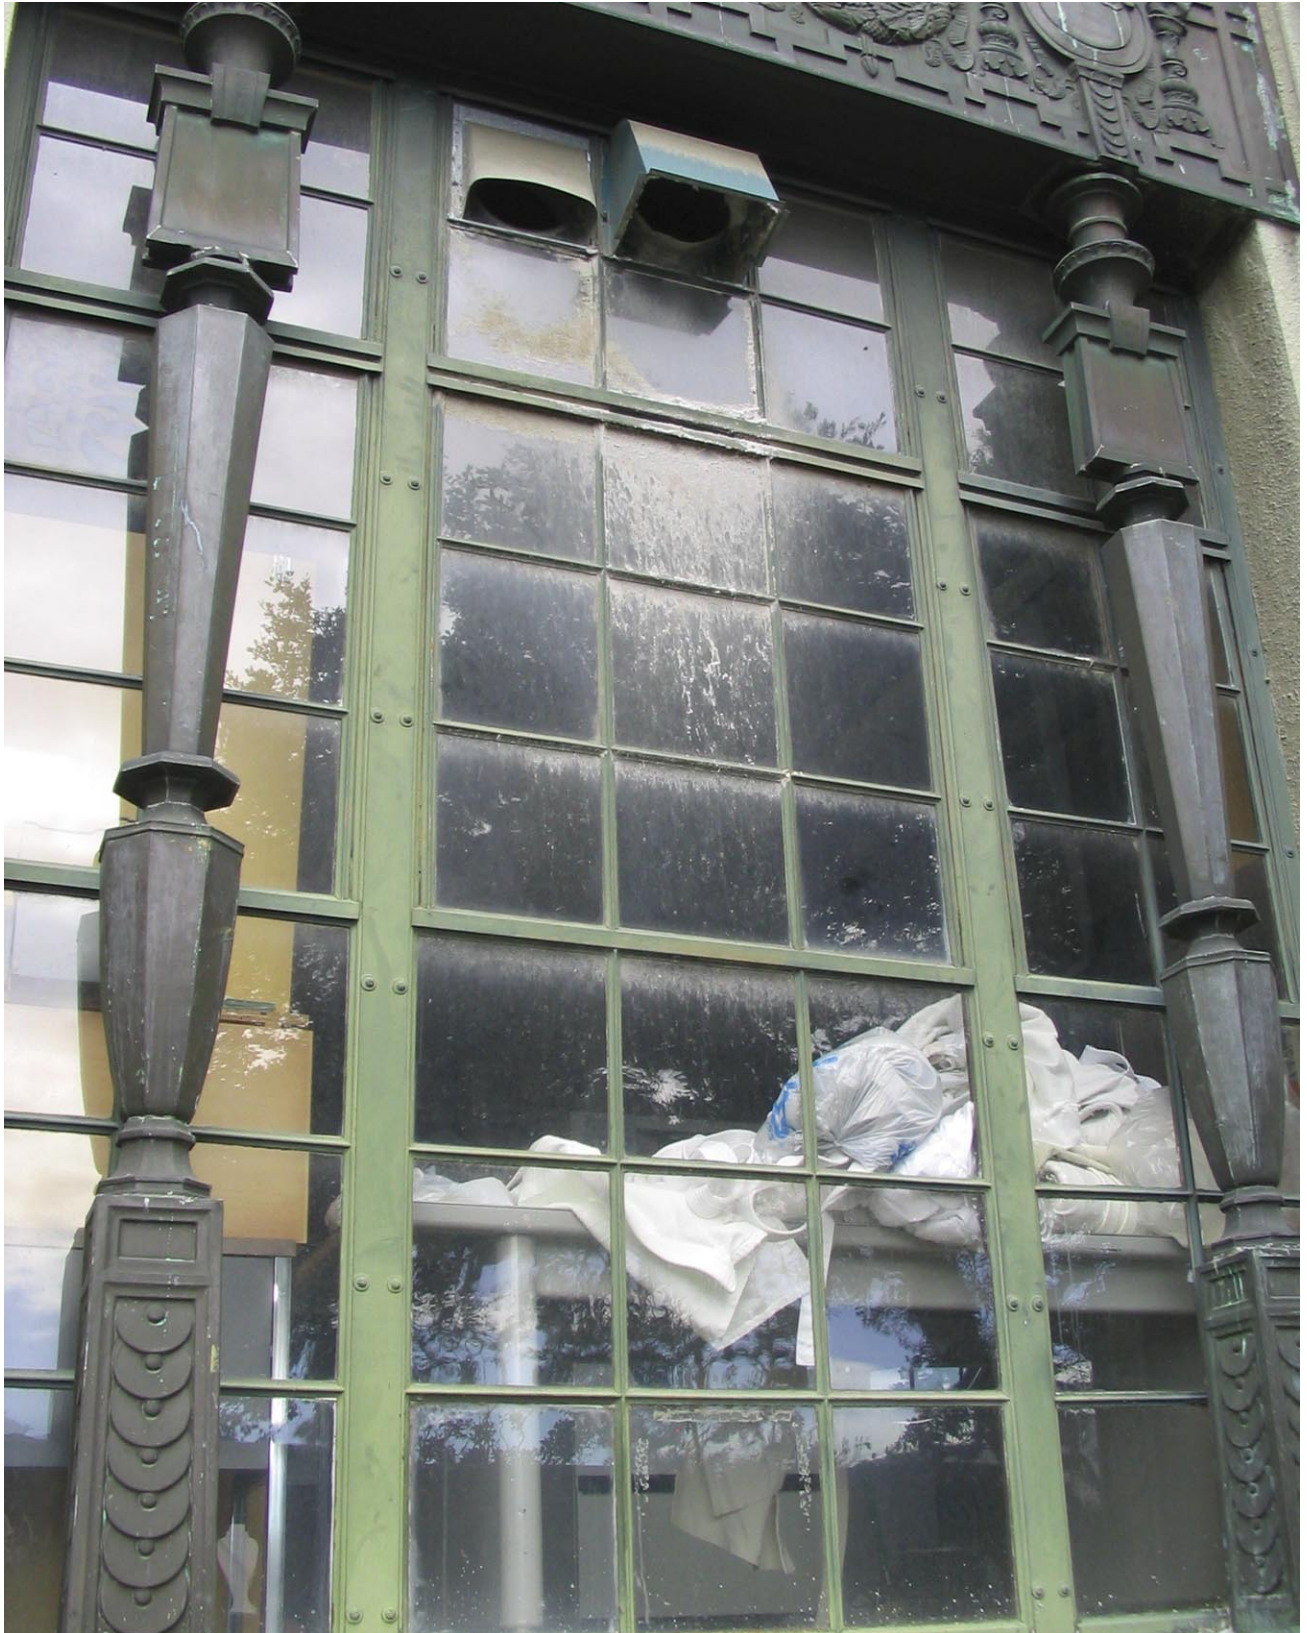
Vents and grilles should be removed from the historic window assemblies, such as this window near the west entry

3.2	Consider removing doors and partitions in the North Corridor.	
3.3	Consider removing modular rubber mats from the Weight Room.	
3.4	Remove grilles, vents and mechanical systems from historic and highly visible windows, such as the laundry vents at the west entrance, the weight room vents at the east entry , and the south facing central pavilion at the women's locker room.
